WOOD DESTROYING PESTS AND ORGANISMS INSPECTION REPORT

Building No. 5764	Street Griffith Ave.	City Marysville	Zip 95901	Date of Inspection 1/14/2012	Number of Pages 6
Excalibur Exterminators 1000 Lincoln Rd. Suite H #154 Yuba City CA 95991 Tel 530-671-9223 Fax 530-671-9523 Alt 751-6169 excaliburext@hotmail.com				Report # : 24928 Registration # : PR3852 Escrow # : <input type="checkbox"/> CORRECTED REPORT	
Ordered by: Derek Sandgren Helm Properties 1520 Butte House Rd Yuba City CA 95993		Property Owner and/or Party of Interest: County of Yuba		Report sent to: Derek Sandgren Helm Properties 1520 Butte House Rd Yuba City CA 95993	
COMPLETE REPORT <input checked="" type="checkbox"/> LIMITED REPORT <input type="checkbox"/> SUPPLEMENTAL REPORT <input type="checkbox"/> REINSPECTION REPORT <input type="checkbox"/>					
GENERAL DESCRIPTION: One story frame dwelling, wood siding, raised foundation, vacant, composition roof.				Inspection Tag Posted: GARAGE

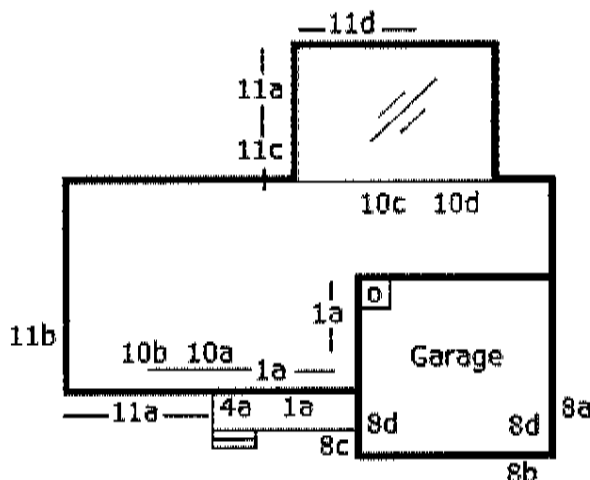
Diagram Not To Scale

Subterranean termite evidence noted in sub area adjacent front porch area and under hall bathroom.

Drill holes through front porch cap concrete slab as indicated on diagram, pressure treat areas under slab with a State registered chemical as per label instructions and State regulations. After treatment is completed, seal all holes drilled into slab areas.
